Utilisation of structural steel in buildings: supporting information

Muiris C. Moynihan and Julian M. Allwood*

This document contains supplementary information as described in the journal article “Utilisation of structural steel in construction”. It is divided into 3 sections:

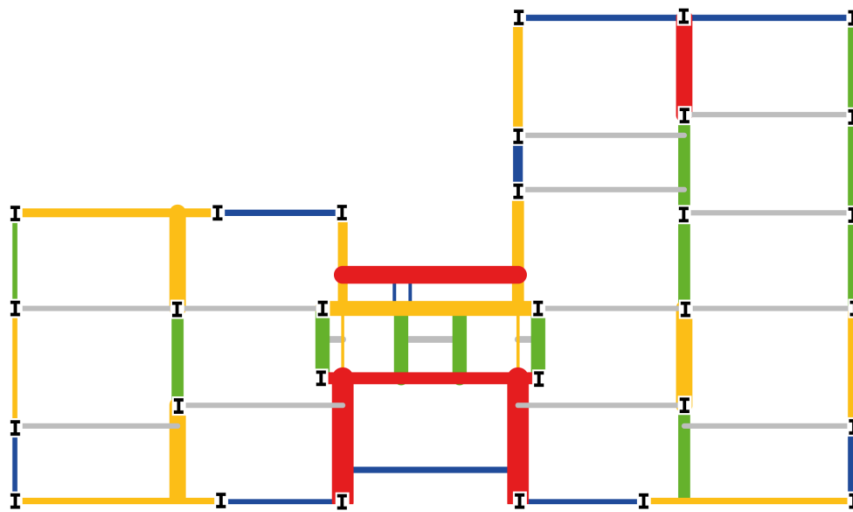
1st floor

Figure 2: plot of floor showing beams coloured according to utilisation ratio (as per legend pg. S2)

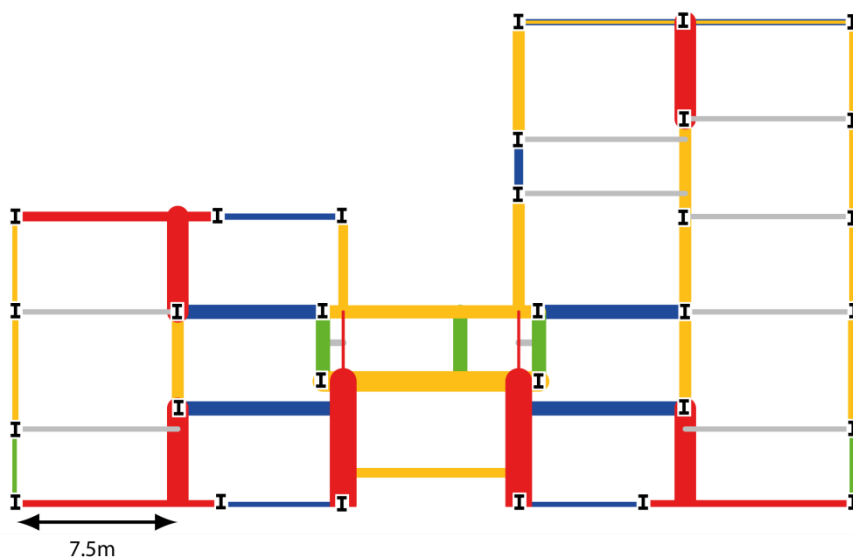
Plant level

Figure 3: plot of floor showing beams coloured according to utilisation ratio (as per legend pg. S2)

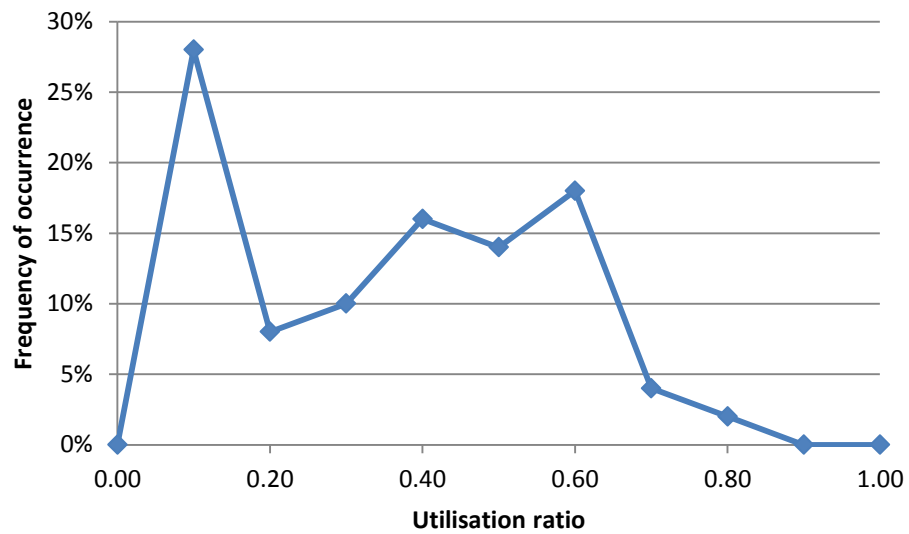
Figure 4: graph of frequency of occurrence against utilisation ratio for columns by floor and overall for building #1

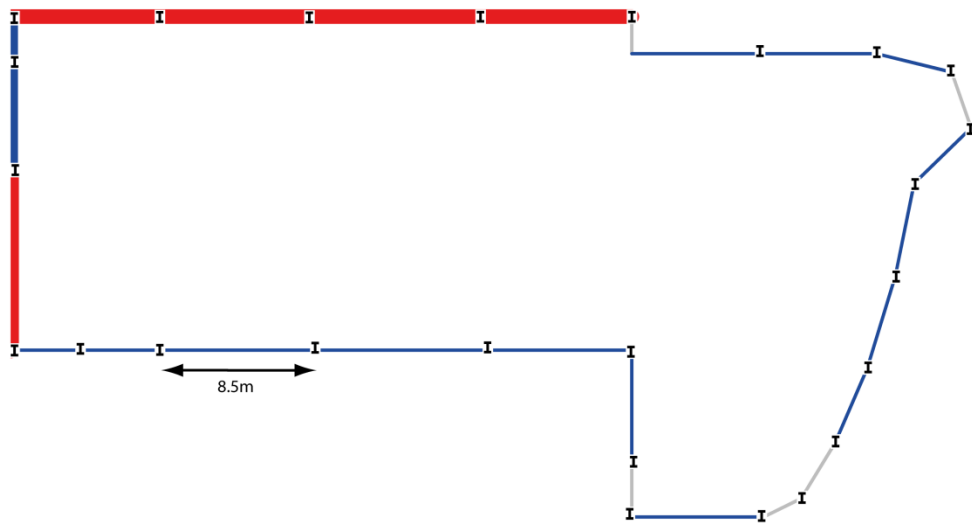
1st floor

Figure 10: plot of floor showing beams coloured according to utilisation ratio (as per legend pg. S2)

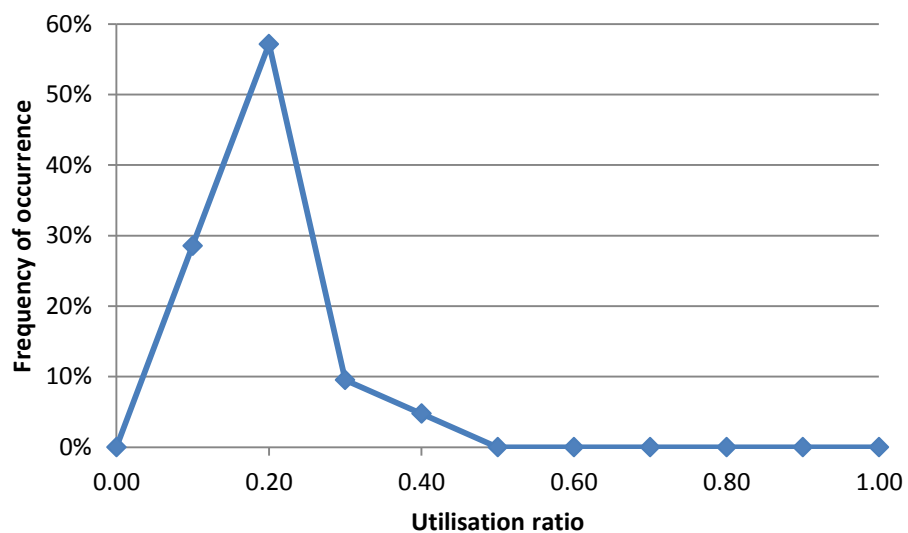
Figure 17: graph of frequency of occurrence against utilisation ratio for columns by floor and overall for building #4

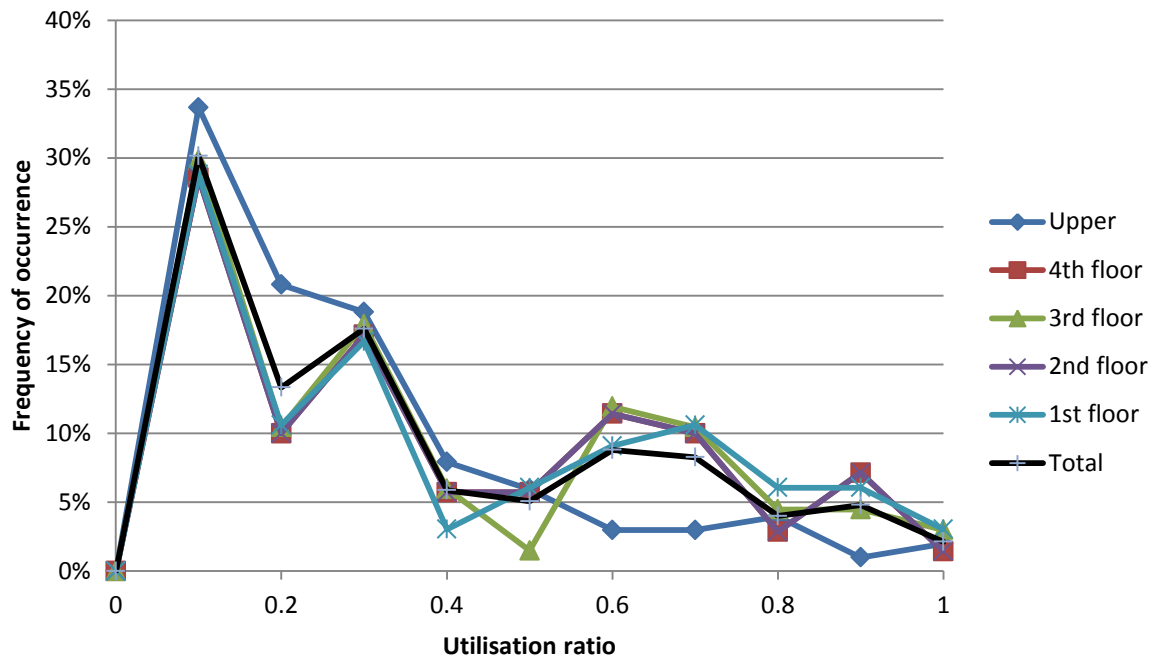
Figure 32: graph of frequency of occurrence against utilisation ratio for beams by floor and in total for building #8

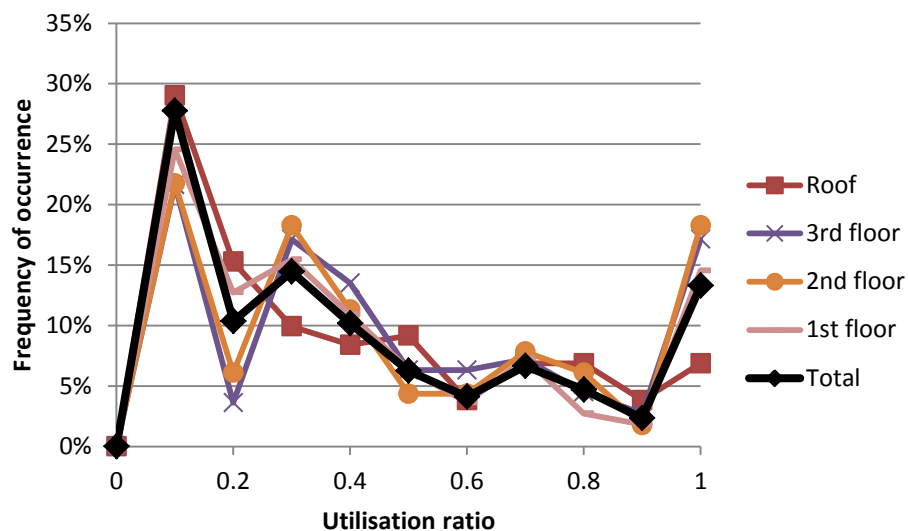
Figure 34: graph of frequency of occurrence against utilisation ratio for beams by floor and overall for building #9

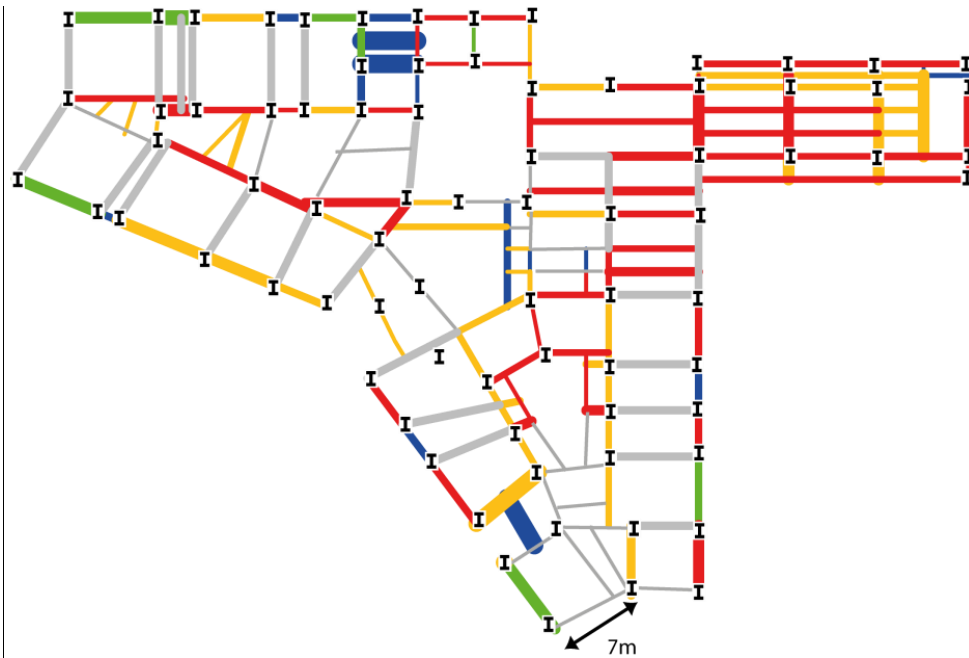
1st floor

Figure 41: plot of floor showing beams coloured according to utilisation ratio (as per legend pg. S2)

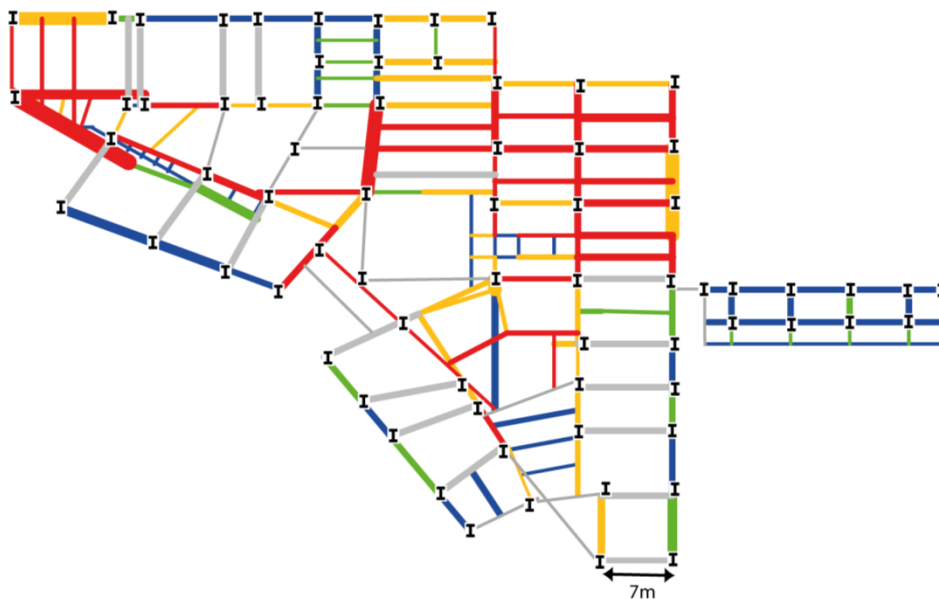
2nd floor

Figure 42: plot of floor showing beams coloured according to utilisation ratio (as per legend pg. S2)

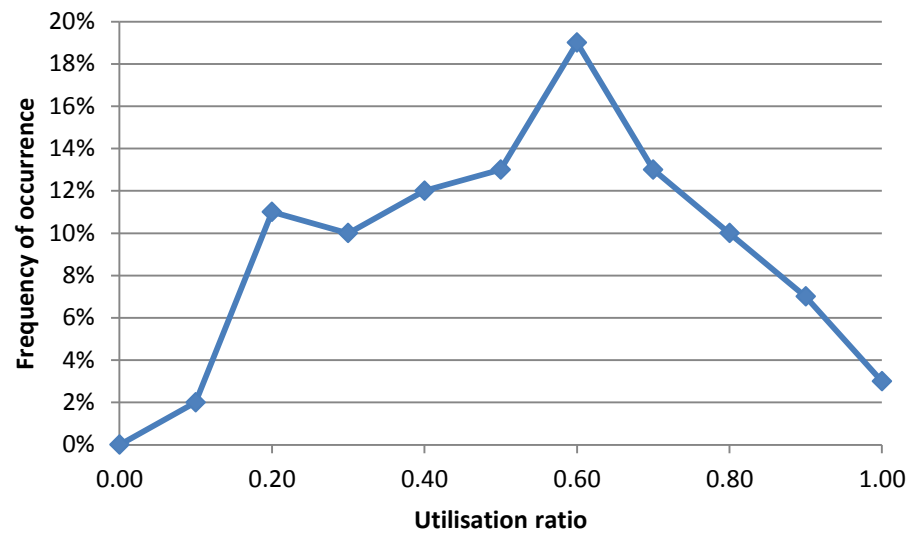
Figure 43: graph of frequency of occurrence against utilisation ratio for columns by floor and overall for building #12

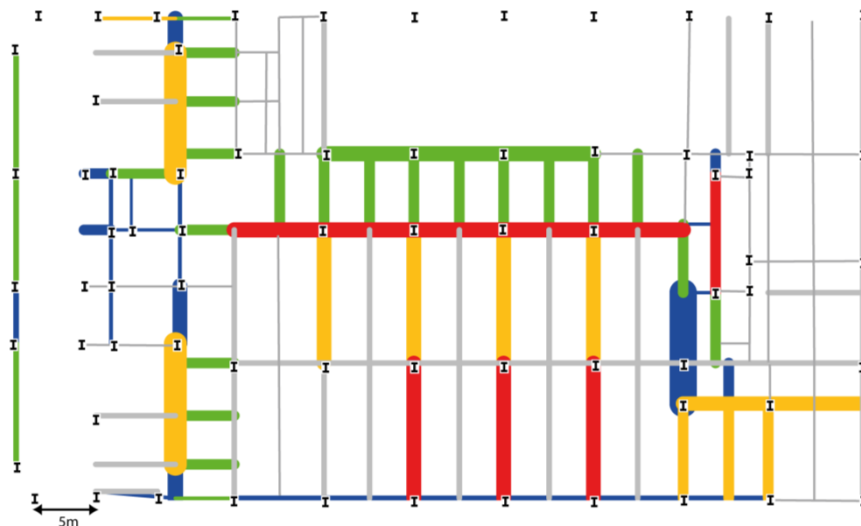
Ground floor

Figure 54: plot of floor showing beams coloured according to utilisation ratio (as per legend pg. S2)

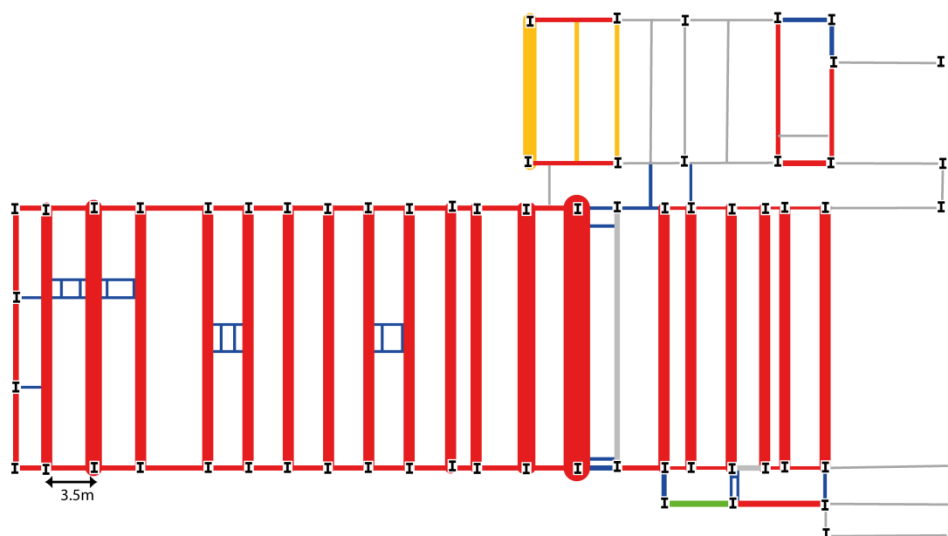
Figure 75: plot of floor showing beams coloured according to utilisation ratio (as per legend pg. S2)

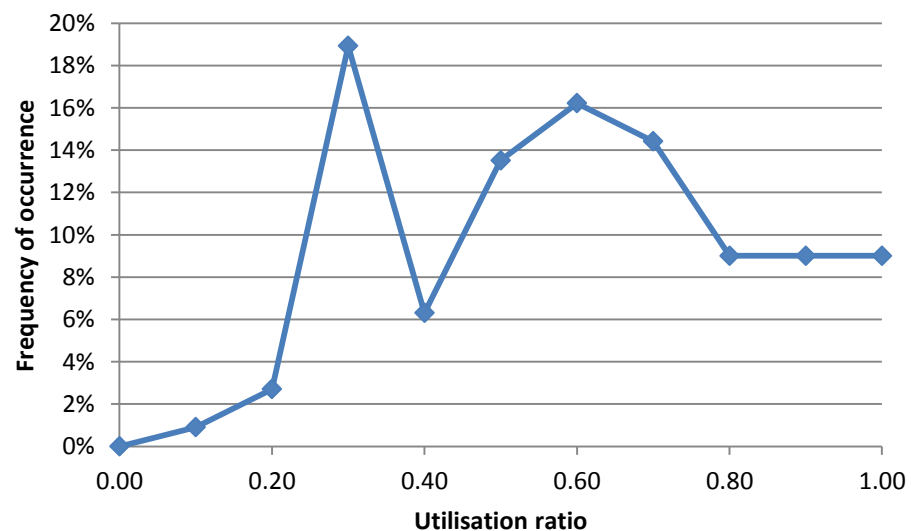
Figure 84: graph of frequency of occurrence against utilisation ratio for columns by floor and overall for building #22
